# Factors Controlling the Formation of Collapse Disasters and Its Hazards to Power Transmission Projects in Erlang Mountain – Zheduo Mountain, China

## Abstract

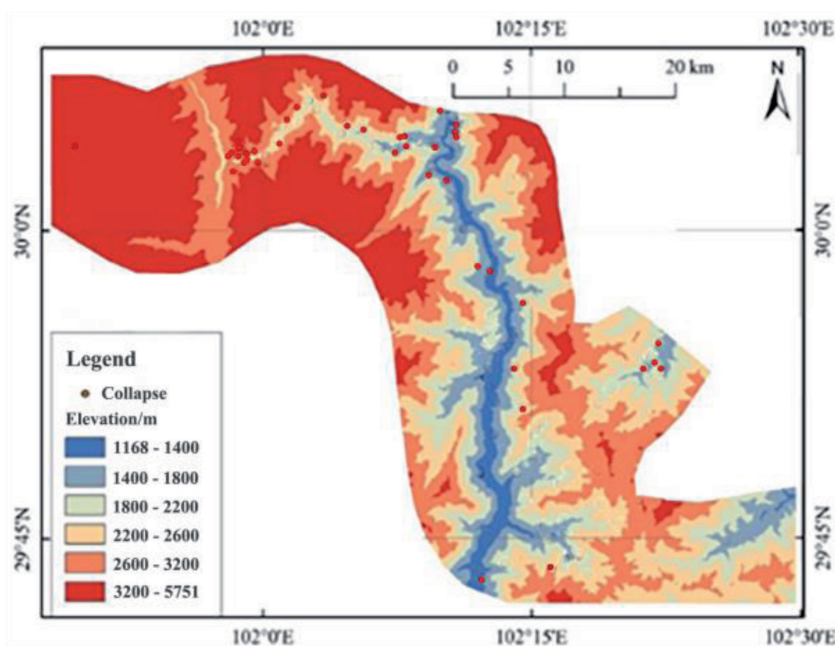
Fig. 1. The distribution map of geological disasters and elevation in the study area

The relationship between the distribution of geological disasters in the study area and the elevation is shown in Fig.1. The collapse disasters are mainly distributed along the Kangding River in the northwest. The elevation ranges with the highest number of collapse disasters are 2600 - 3200 m, 1800 - 2200 m, and 1400 - 1800 m, respectively. A total of 34 collapses are distributed, accounting for 81% of the total number of collapses.

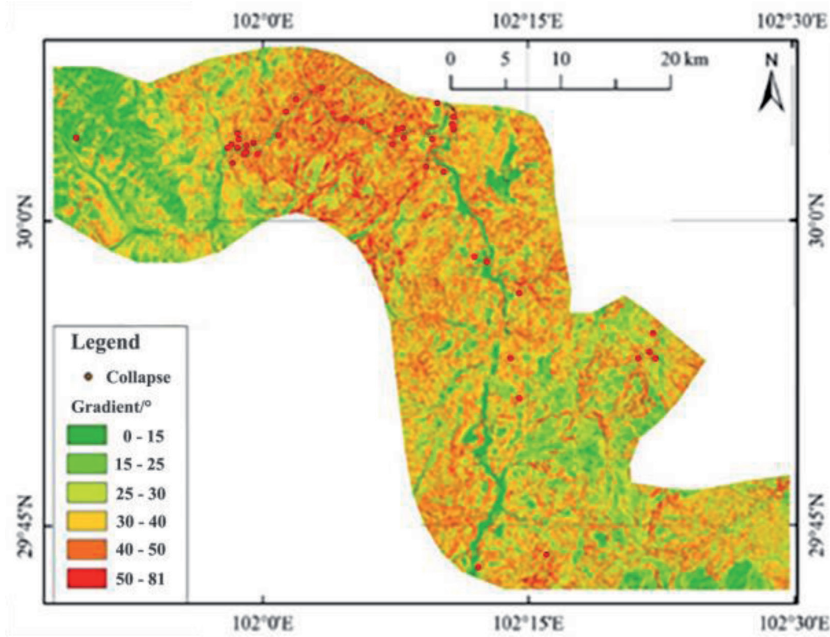
Fig. 2. The relation between the distribution of collapse disasters and slope gradient

The steeper the slope gradient, the more it is prone to geologic hazards. The slope significantly affects the stress redistribution and stress differentiation process of the slope rock and soil mass. With the steepening of the slope, the larger the distribution range and value of the tensile stress at the trailing edge of the slope, the more significant the shear stress concentration at the foot of the slope. The high and steep slope is not conducive to the stability of the slope rock and soil mass. The relationship between geological disaster distribution and slope is shown in Fig. 2.

It shows that the slope in the study area is mainly between 15° and 50°, and the slope of 30°~40° is the most

developed, followed by the slope of 40°~ 50°. The study area is a typical deep - cut gorge geomorphology. The slope ranges with the largest number of collapse disasters are 40°~ 50°, 30°~ 40°, and 50°~ 81°, respectively. A total of 30 collapses are distributed, accounting for 71.4% of the total number of collapses. The number of collapse disasters increases with the increase of slope.

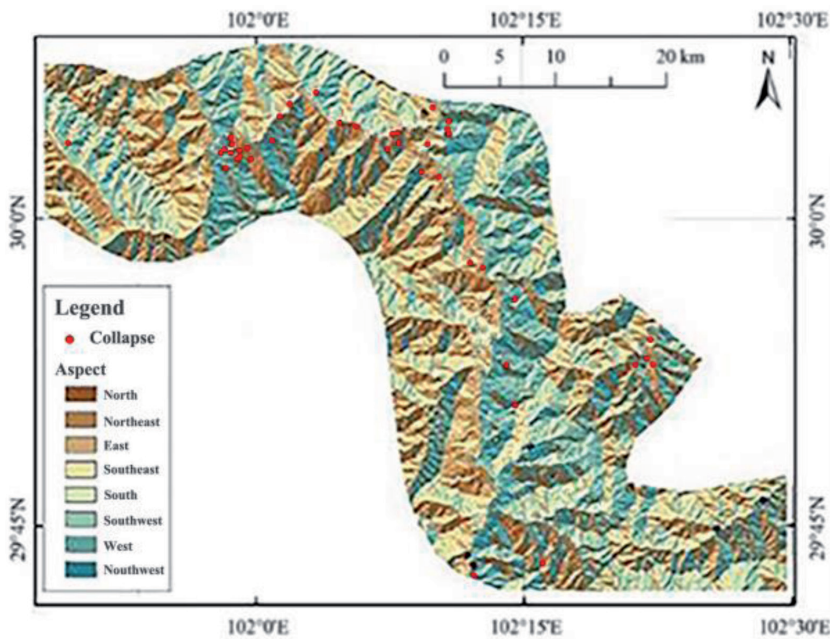
Fig. 3. The relation between the distribution of collapse disasters and slope orientation

addition, it affects the development of vegetation on the slope surface and the degree of weathering denudation. The distribution of geological disasters and slope direction in the study area is shown in Fig. 3.

It shows that the slope direction in the study area is basically evenly distributed, and the distribution of geological disasters by slope direction does not show significant regularity. The slope areas have a lot of collapse disasters with a total of 23 collapses, accounting for 56.1% of the total number of collapses, which are successively southeast, northwest, and southwest.

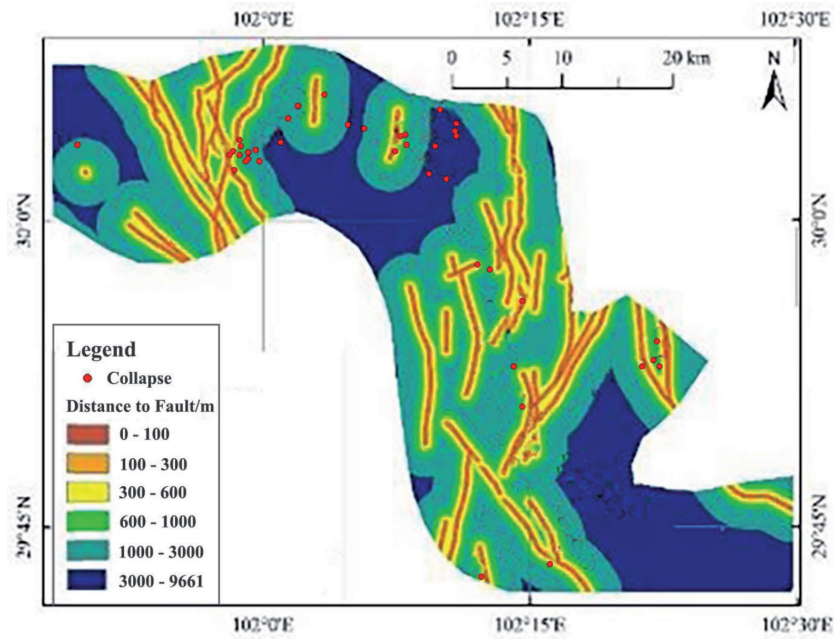
Fig. 4. The relation between the distribution of collapse disasters and distance from faults

The geological structure in the study area is complex and the faults are developed. Generally, the closer the distance from the fault is, the stronger the influence of tectonic action on the stability of rock and soil mass is, and the more prone it is to lead to geological disasters. In this paper, the distance from the fault lines is used to measure the influence of tectonic action on the stability of rock and soil. The distribution map of collapse disaster development and fault distance in the study area is shown in Fig.4. It shows that there are 46 geological disasters distributed in

the 1000 - 3000 m distance from the faults in the study area, accounting for 30.9% of the total number of geological disasters; besides, there are 33 geological disasters in the range of 3000 - 9661 m, accounting for 22.1% of the total number of geological disasters. The geological disasters in the remaining sections are basically evenly distributed.

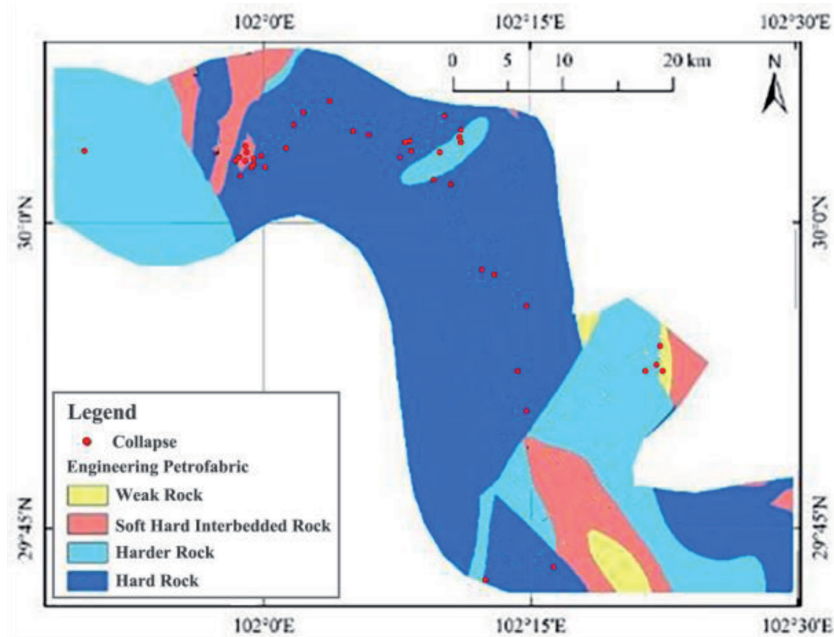
Fig. 5. The relation between the distribution of collapse disasters and rock formation

complex, soft-hard alternant strata, and weak lays. The distribution map of geological disasters and engineering rock groups in the study area is shown in Fig. 5.

It shows that the number of engineering geological formation complexes in the study area is rigid formation complex, relatively rigid formation complex, soft-hard alternant strata, and weak lays. These proportions are 58.8, 30.1%, 9.3%, and 1.8% respectively. The collapse disasters in the study area are mainly developed in the early Proterozoic acid rock, the Paleoproterozoic acid rock, the Nanhua period acid rock and the Kangding group complex. The lithology is mainly composed of quartz diorite, granite, amphibolite, and other rigid or relatively rigid rocks. These rigid rock masses can form steep slopes, which are conducive to the concentration of tensile stress at the trailing edge of the slope. The rock can promote tensile fractures at the trailing edge of the slope, which is prone to collapse under rainfall conditions.

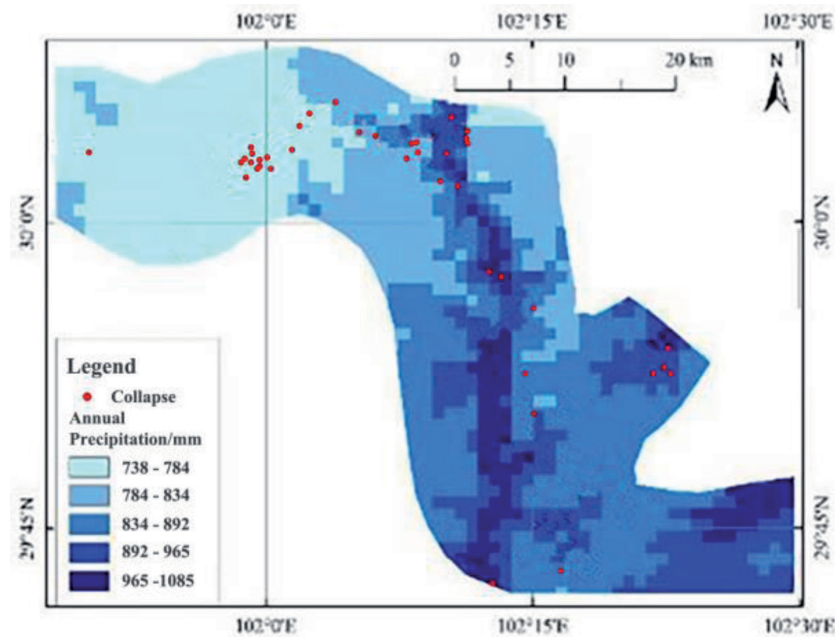
Fig. 6. The relation between the distribution of collapse disasters and annual rainfall

Rainfall can significantly reduce the stability of slope rock and soil mass, which is an important geological disaster inducing factor. This paper uses multi-year average rainfall for analysis. The distribution of collapse disasters and annual rainfall in the study area is shown in Fig.6. It shows that the collapse disasters in the study area are mainly distributed in the area with rainfall of 834 - 965mm, and the number of collapses in this area is 22, accounting for 52.4%.

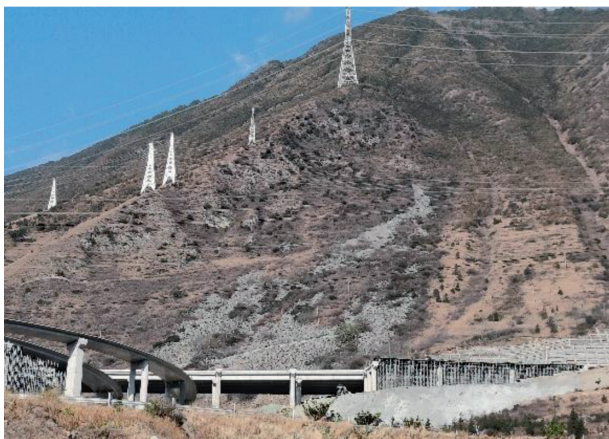
Fig. 7. Characteristics of No.4 collapse based on filed investigation

The No.4 collapse is located on the edge of Yakang Expressway. The geographic coordinate is 102° 21' 20", 29° 58' 12", and the slope direction is 95°. The remote sensing image and on - site investigation can see a clear collapse boundary, which belongs to medium-sized rock collapse (Fig. 7). The rock mass in the collapse source area of the No.4 collapse is steeply inclined. The collapse deposits are developed under the current conditions. The formation mechanism should be sliding or falling collapse. The stable state under the current conditions is basically stable to less stable. There are multiple transmission tower foundations arranged above it. Rainfall will reduce the stability of the collapse. There is the possibility of instability, which poses a serious threat to the stability of the transmission tower, and even leads to the collapse of the transmission tower.
